A correlation between damage and intensity on old masonry churches in Colima, Mexico by the 2003 M7.5 earthquake

Strong damage was observed in Colima Mexico on most of the cultural patrimony (mainly churches) after the 2003 M7.5 earthquake. In order to find a correlation between the observed damage on the historical buildings and the earthquake intensity, the vulnerability is assessed by qualitative methods, including the vulnerability class method (VCM) and the vulnerability index method (VIM). The latter method is modified and adapted in this research to assess the seismic vulnerability of historical buildings such as churches and cathedrals located in areas from high to very high seismicity. The results are intended to serve as preliminary indicators of expected damage levels that allow the local authorities to take measures oriented to disaster prevention. The assessment using both methodologies is developed on 15 historical masonry churches, most of them from XIX century. With the results, a correlation between damage and intensity taking into account a Macroseismic Scale is developed and the qualitative methodologies to assess the seismic vulnerability of historical construc

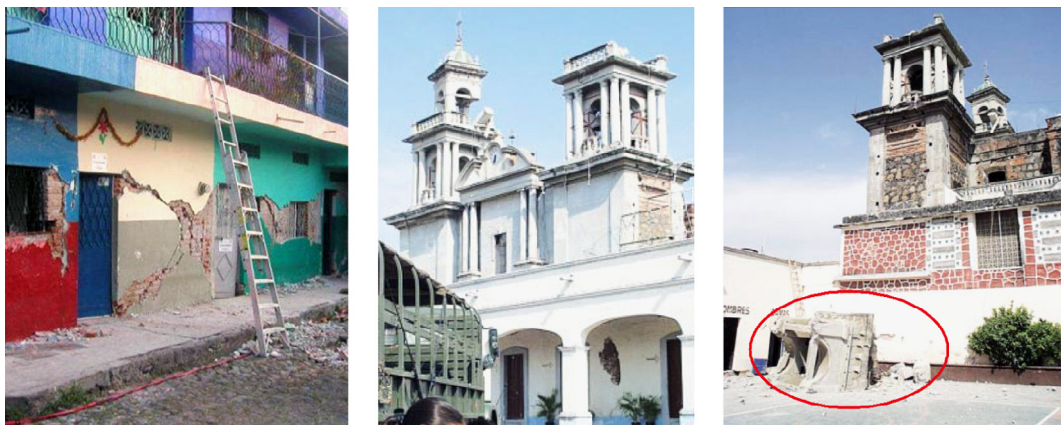
Fig. 2. Observed damages on churches after the 2003 M7.5 Colima, Mexico EQ.
